# **Air Leakage and Moisture Intrusion in Single-Wythe Masonry Walls**

## / Buildings, Commercial, Moisture / By Harold Decelle and Matt Durbin

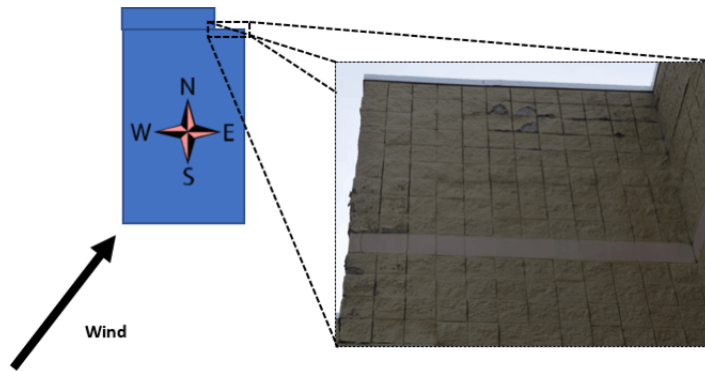
Figure 1: Moisture Damage from Accelerated Air Leakage caused from Negative Pressure

side of the wind, pulling interior air through the wall at deficiencies. In the winter, the interior air is typically warmer and moister than the outside air. If wind comes from the Southwest, and there is a bump-out on the opposite side (Northwest), negative pressure will form in this inside corner, potentially pulling the warm, moist interior air out through openings or other air leakage sites. Freezing can lead to deterioration and spalling of mortar and block. See Figure 1 for an example.

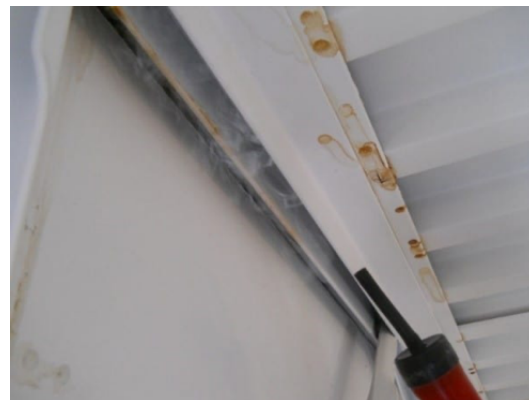
Figure 2: Smoke escaping at Roof/Wall Junction

(Smoke Tracer or Theatrical Fog in Conjunction with Building Pressurization or Depressurization). Smoke tracers are typically used in the interior because there is less air movement inside the building than on the outside. If the smoke moves away from the wall, there is air movement into the building. If the smoke disappears into the wall, air leakage is from the inside out. If the smoke hangs in place, the test area is free of leakage. The test is often used at roof/wall junctions and around penetrations in the wall such as gaps around girder supports, as these are major air leakage points (Figure 2).

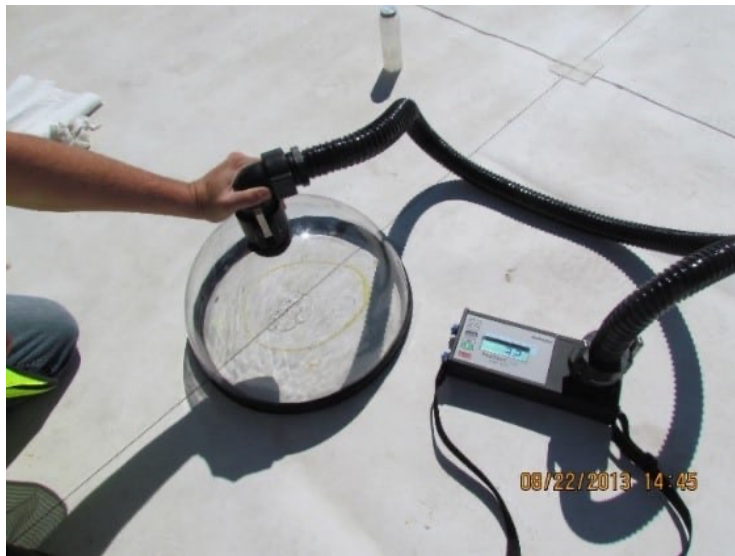
Figure 3 – Testing of roof seam shows air leakage

Depressurization in Conjunction with Leak Detection Liquid). In this case a leak detection fluid (soap-like fluid) is applied to the surface and a dome placed over the test area. A pressure differential is created inside the dome. Bubbles in the fluid indicate air leakage. This method can be used to detect air leakage in coatings applied to block, at penetrations during construction (such as brick ties), and at roof seams and other junctions (Figure

3).

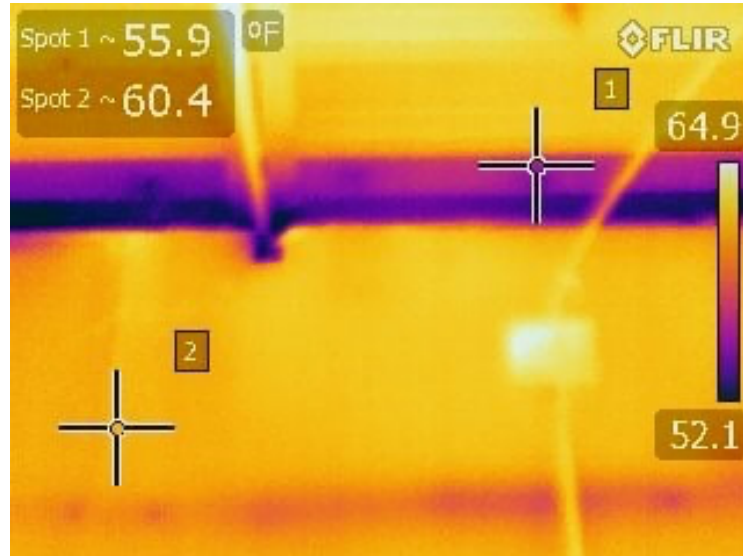
Figure 4: Air Leakage at junction between roof and wall evidenced by temperature differential

In both cases, temperatures at leakage sites will be different than the surrounding temperatures. Infrared cameras can be used to measure temperature differentials to identify air leakage. Darker colors in thermal images represent colder areas; lighter colors represent warmer ones (Figure 4). In a simple wall assembly involving single-wythe concrete masonry block, areas of block, grout, or insulation that are damp retain heat longer than corresponding areas that are dry. Late at night, moisture will show up lighter since it retains the heat from the day. Early in the morning as the wall starts to heat up, the water takes longer to heat up and will appear darker (Figure 5). Accordingly, experience and expertise are required when determining the best time to take infrared images, and in interpreting the results.

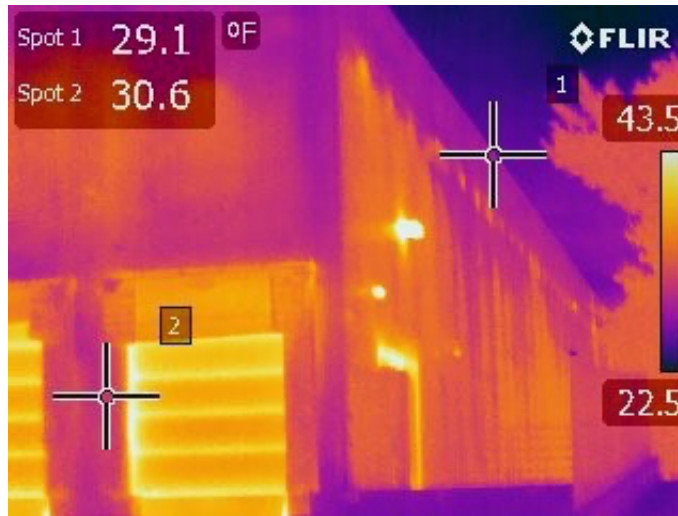
Figure 5: Infrared camera used to identify high moisture content early in the morning

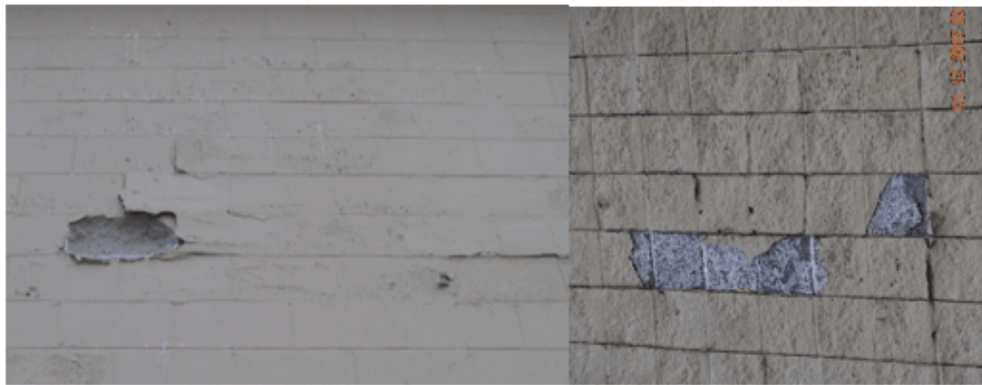
Figure 7: Excessive Peeling, Efflorescence, Cracking, and Spalling originating near roofline

A case study helps to illustrate the use of the various techniques described above. A single-wythe CMU building in Nebraska was experiencing widespread paint failures, significant cracking of walls, deteriorated mortar joints, spalling block, and efflorescence (Figure 7 shows the condition in 2017). Photos of the building were originally taken in 2011, but no remedial work was performed. A comparison of the same wall between 2011 and 2017 is shown in Figure 8. By comparing the photos, it is obvious that the conditions worsened. A common factor present throughout the building was that the moisture failures started near the roofline and carried downward in the wall, lessening closer to the ground. Moisture meters and the infrared camera were used to prove moisture was present and was responsible for the problems, and the roofline was closely investigated, with smoke tests performed and temperature differentials studied. It was concluded that the failures on the west side of the building were occurring at the roof line and along the roof girders where no air barrier had been installed. Figures 9-11 illustrate the exterior wall condition, interior infrared photos showing air leakage, and roof infrared photos showing heat escaping at the roof/wall junction and girder. The inside corner on the northeast corner of the building also had failures near the roof line, but no roof girder was present. It was determined that the failure here was due to a discontinuous air barrier and from pressure differentials when the wind blew from the southwest.

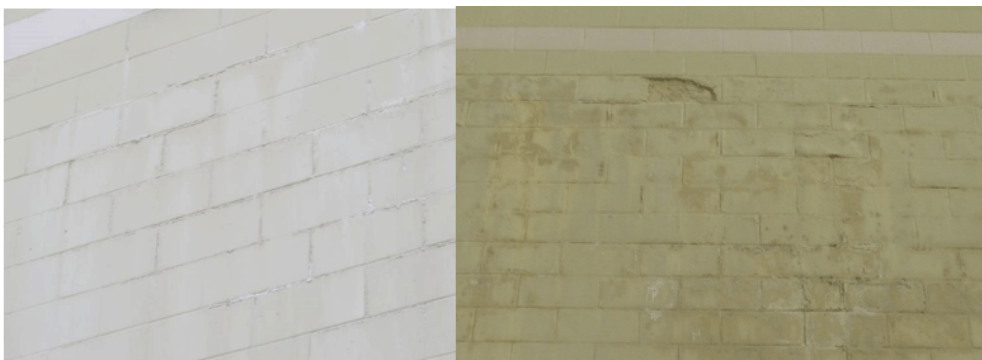
Figure 8: Section of wall worsening over time from 2011 (Left) to 2017 (Right)

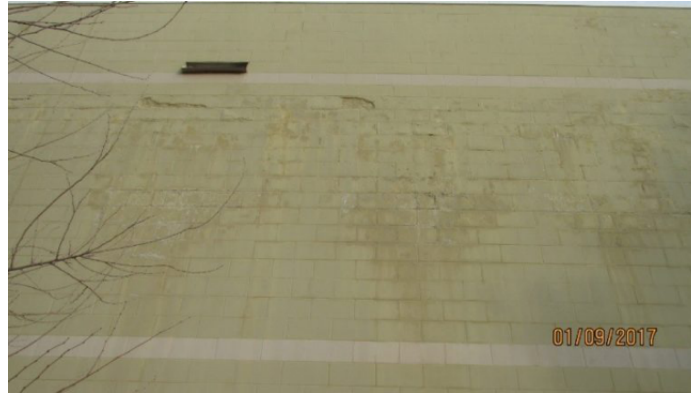
Figure 9: Exterior Wall Condition at Infrared Location shown in Figures 10 and 11.

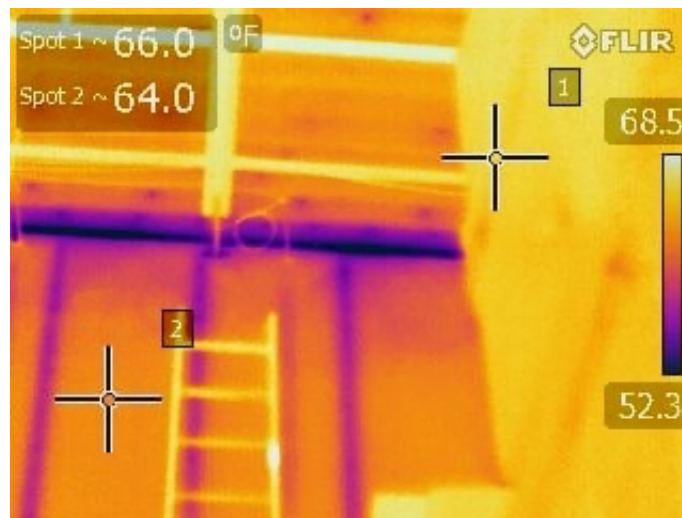
Figure 10: Infrared shows air leakage on interior side of the wall shown in Figure 9.

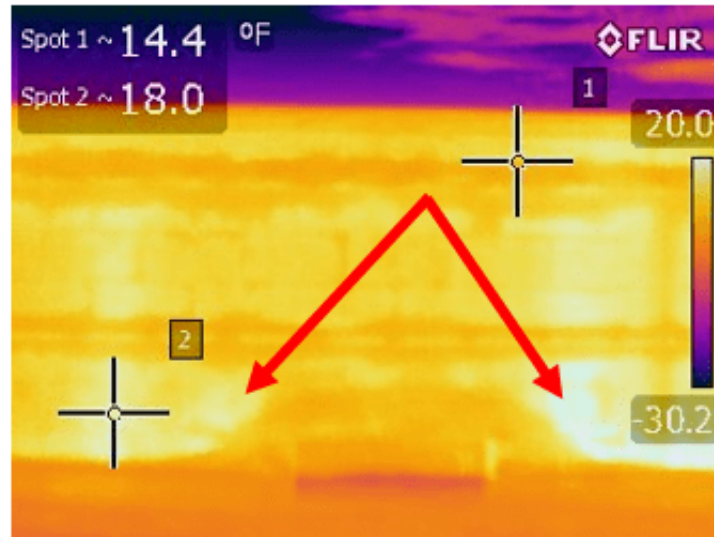
Figure 11: Exterior infrared shows air leakage at roof in same locations shown in Figures 9 and 10.
